Manhole Inspection Summary

Manhole # S43K__012MH

Location Address: **514 BETHEL-BROADWAY-ALLEY** Cross Street: **FLEET-EASTERN-ALLEY**

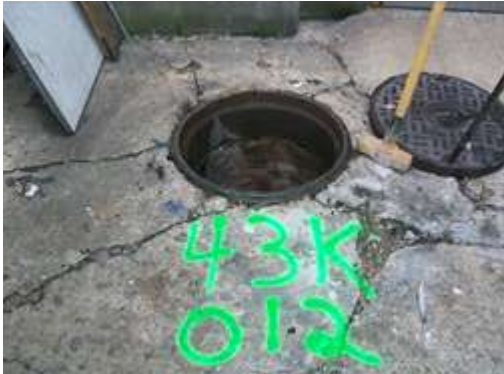
PAVEMENT MARKED

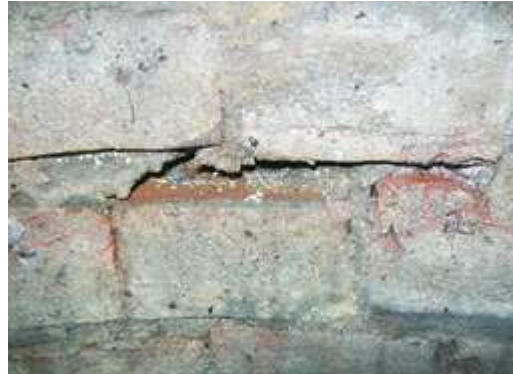
Defect 2

Corbel Material: **Brick** ☐ Parged Type: **Concentric/Eccentric**
Condition: ☐ Sound ☐ Cracked ☐ Root Intrusion ☐ Loose Brick ☒ **Deteriorated**
Infiltration: ☒ None ☐ Joint ☐ Cracks ☐ Mortar ☐ Roots ☐ Wall

DETERIORATED MORTAR @ CORBEL WALL

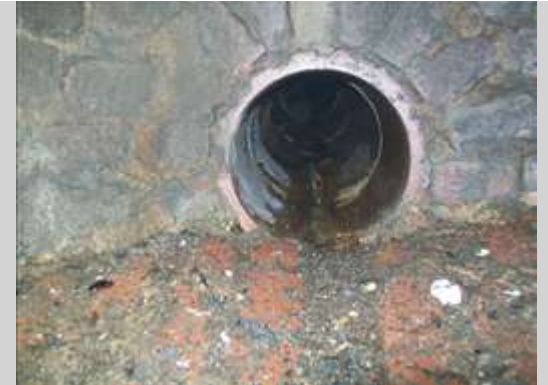
12 O'Clock Outflow

8 in. Circular Gravity Sewer
Pipe Out @ 12 O'Clock

Infiltration: **None** Pipe Seal Cond: **Sound**
